**SIXTH FIVE-YEAR REVIEW REPORT FOR
BAYOU BONFOUCA SUPERFUND SITE
ST. TAMMANY PARISH, LOUISIANA**

JULY 2021

**U.S. Environmental Protection Agency
Region 6
Dallas, Texas**

**SIXTH FIVE-YEAR REVIEW REPORT
BAYOU BONFOUCA SUPERFUND SITE
EPA ID#: LAD980745632
ST. TAMMANY PARISH, LOUISIANA**

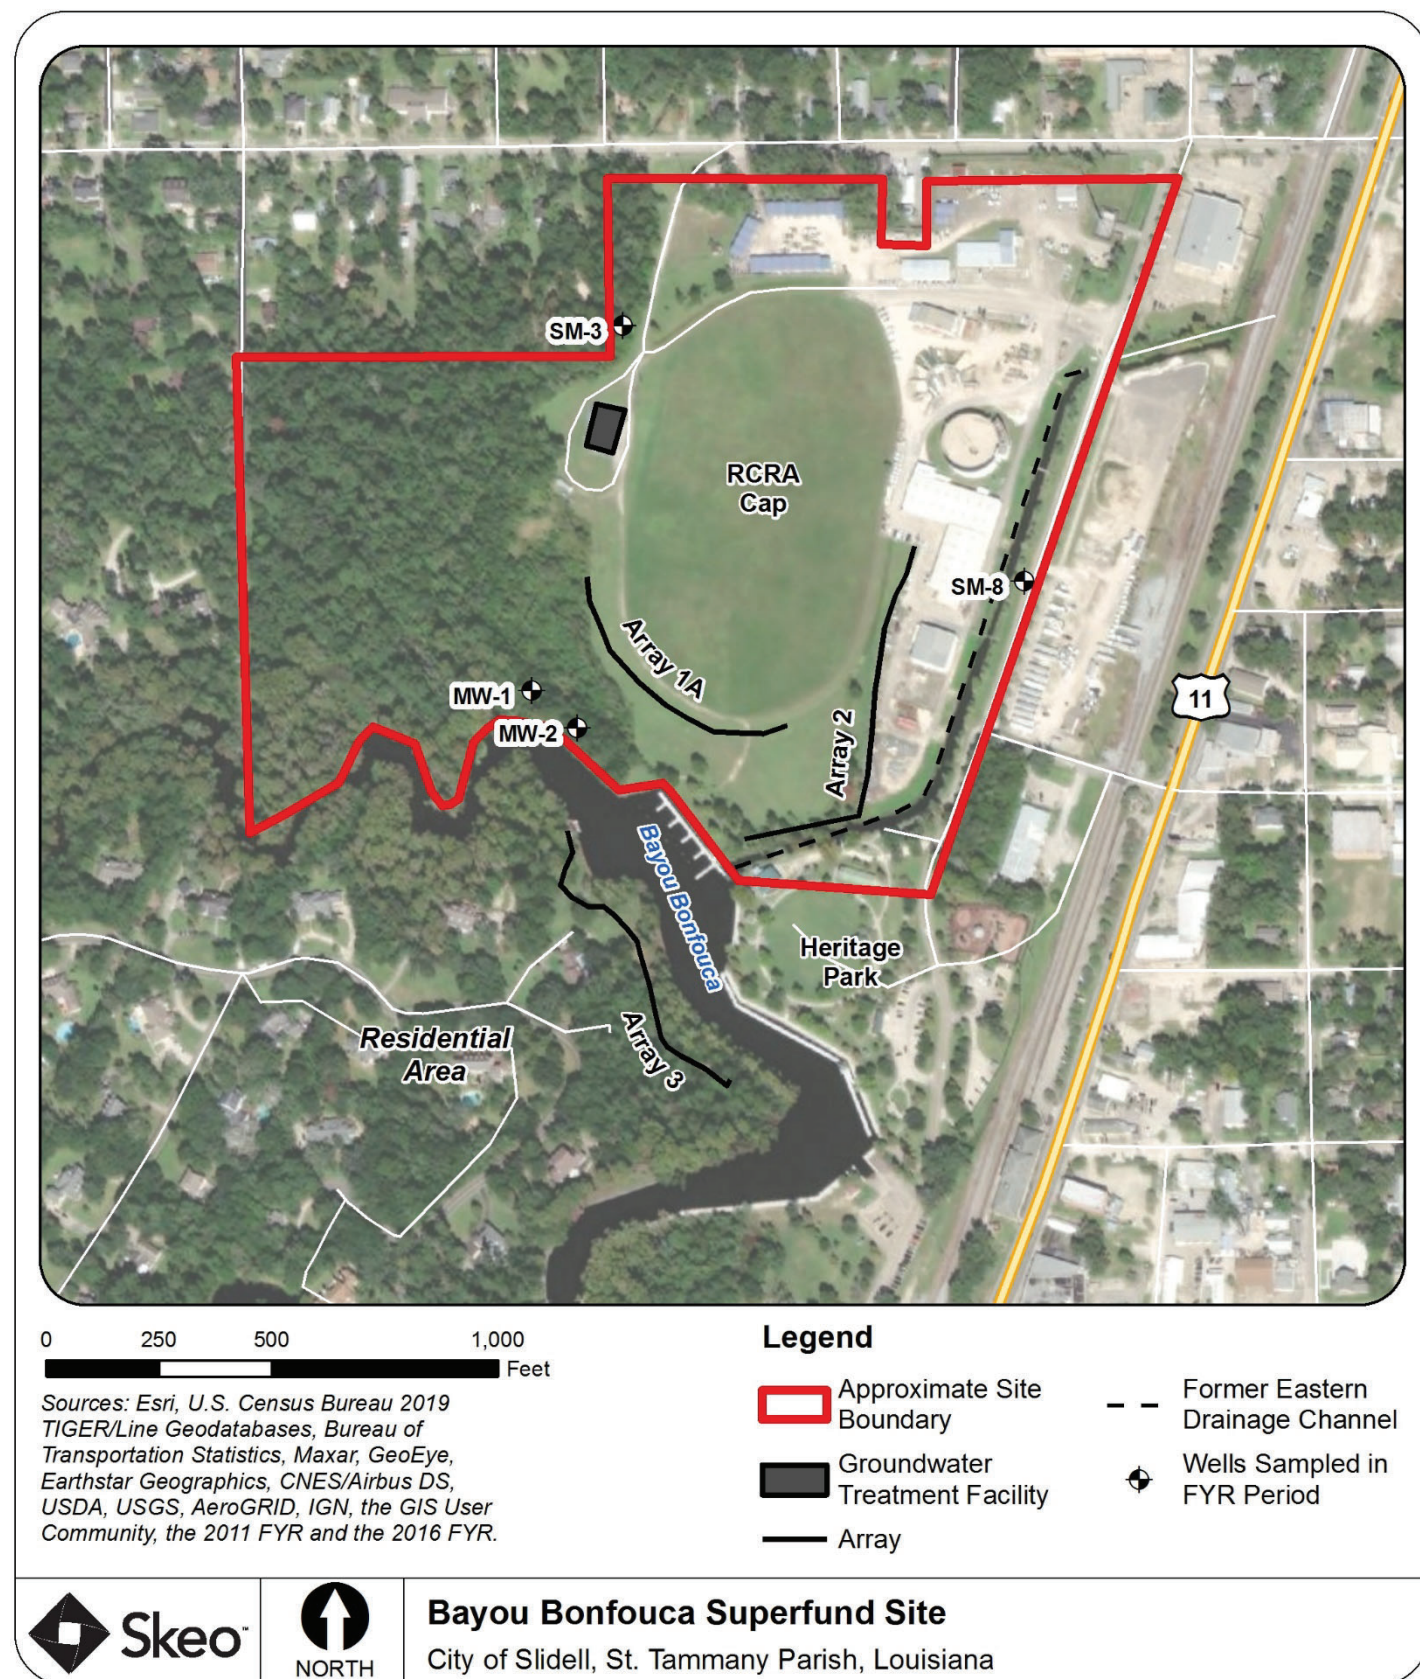
Figure 2: Detailed Site Map

- Extraction well arrays 1a, 2 and 3 (44 total extraction wells) (see Figure 2).
- Treatment building, air compressor (for plant and recovery pumps), and control system for recovery and treatment system.
- Collection system and piping and underground conduits, including a subsurface pipeline and leak detection system to service new extraction wells, and an underground pipeline extending across Bayou Bonfouca, complete with a leak detection sensor for fluid and air conveyance.
- Groundwater and free-phase treatment system (chelating agent, oil/water separator, solids removal filters, organic removal filter and associated tankage).

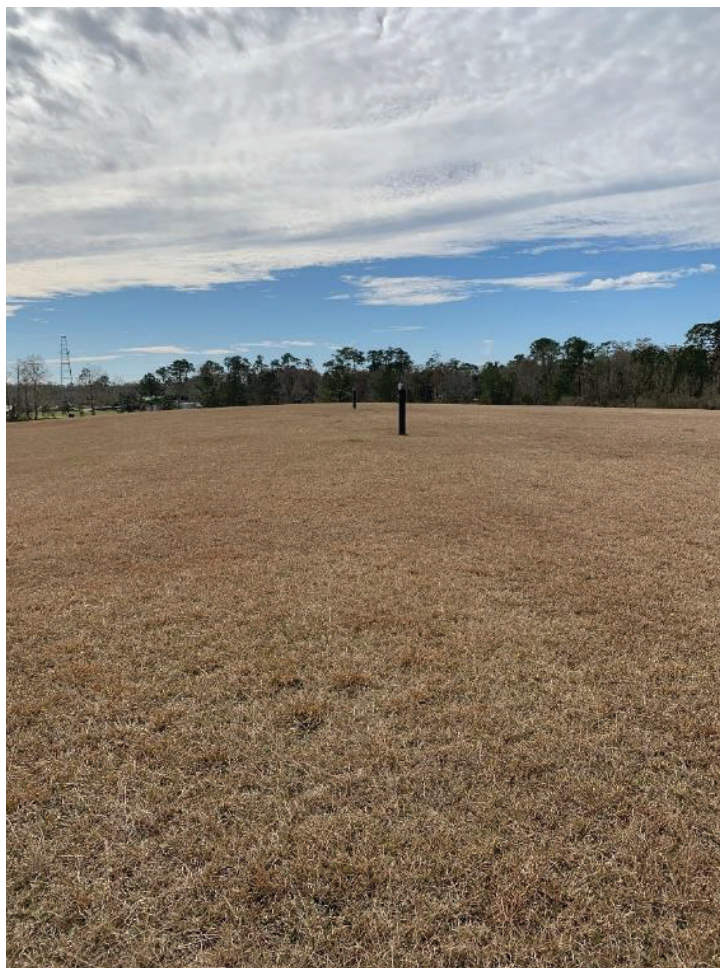
Participants walked the landfill. Passive gas vents located at the top of the landfill as well as landfill drains at the perimeter of the landfill were identified. The landfill cap appeared to be in good condition. Participants observed on-site recovery well Array 2 just east of the landfill. The SEMS contractors identified the replacement recovery wells that had recently been installed. Recovery wells appeared to be in good condition. Site fencing near the landfill and the Site's main entrance were in good condition.

Top of cap, facing south

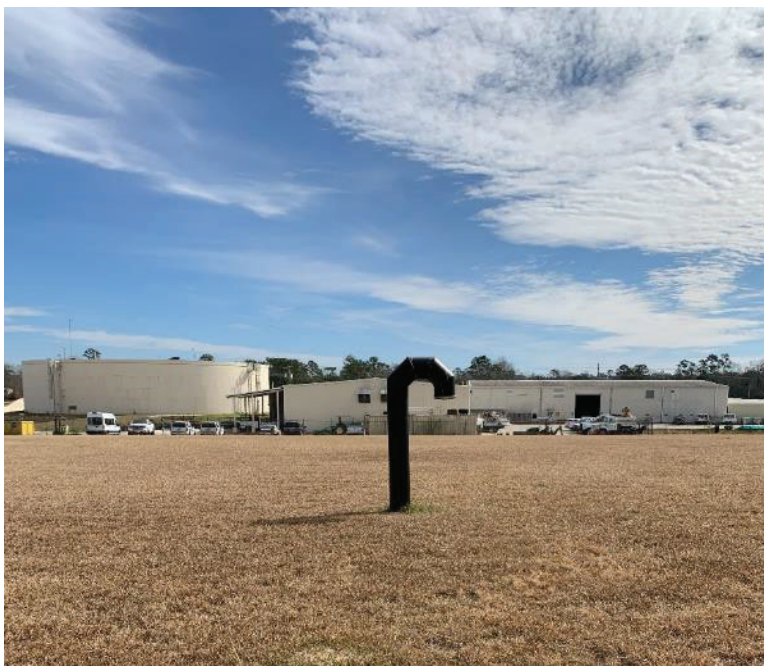
Gas vent

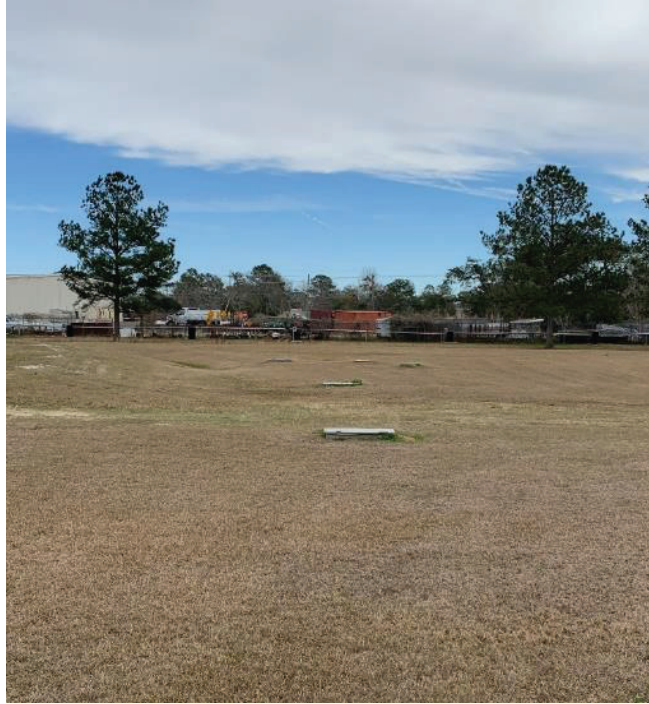
Array 1a, facing east

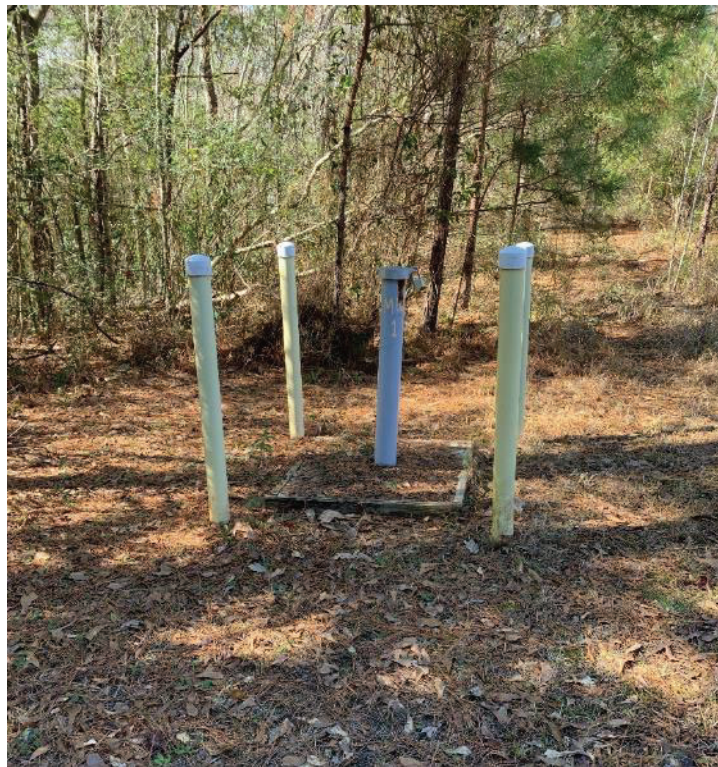
Site inspection participants observed the marina installed adjacent to the Site in 2017 and 2018. SEMS contractors pointed out the area where the underground pipeline extends from the treatment plant to Array 3 across the bayou. Participants observed the nearby pump box as well as the nearby treatment plant discharge pipe actively discharging treated water into the bayou. Participants also observed the sheet piling extending along the eastern and western banks of the bayou where sediment remediation had been completed. Participants viewed one of the 2018 soil sampling locations near the dock (TG44/LB11). Participants then observed on-site recovery well Array 1A near the southwestern edge of the landfill. Recovery wells appeared to be in good condition. Participants also observed monitoring well SM-3 north of the treatment plant building and monitoring wells MW-1 and MW-2 southwest of Array 1A. Wells were capped, locked and in good condition.

MW-1

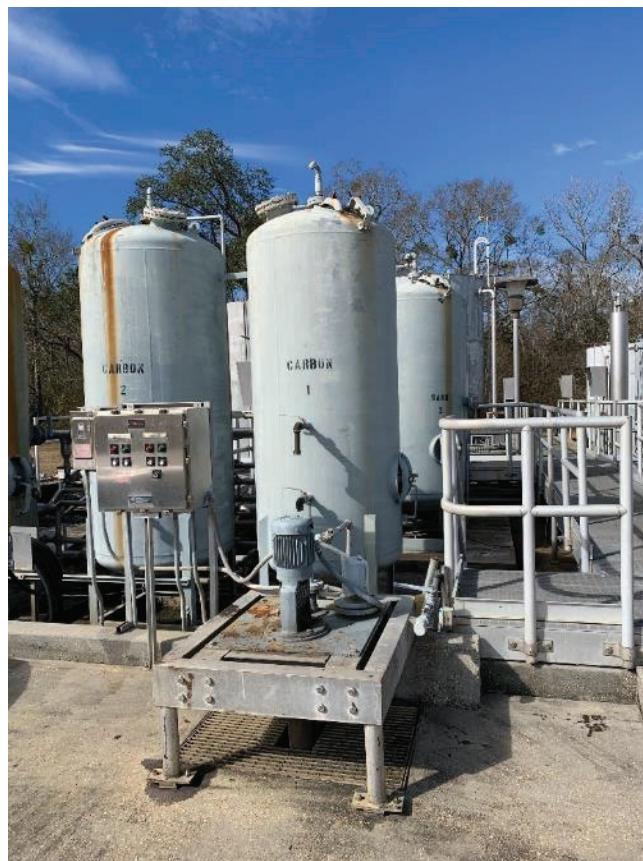
Participants viewed the groundwater treatment plant. The operators provided an overview of the treatment plant operations and then led an inspection of the treatment plant equipment and the operations control center. The components of the treatment system appeared to be in good condition.

Treatment units at groundwater treatment plant

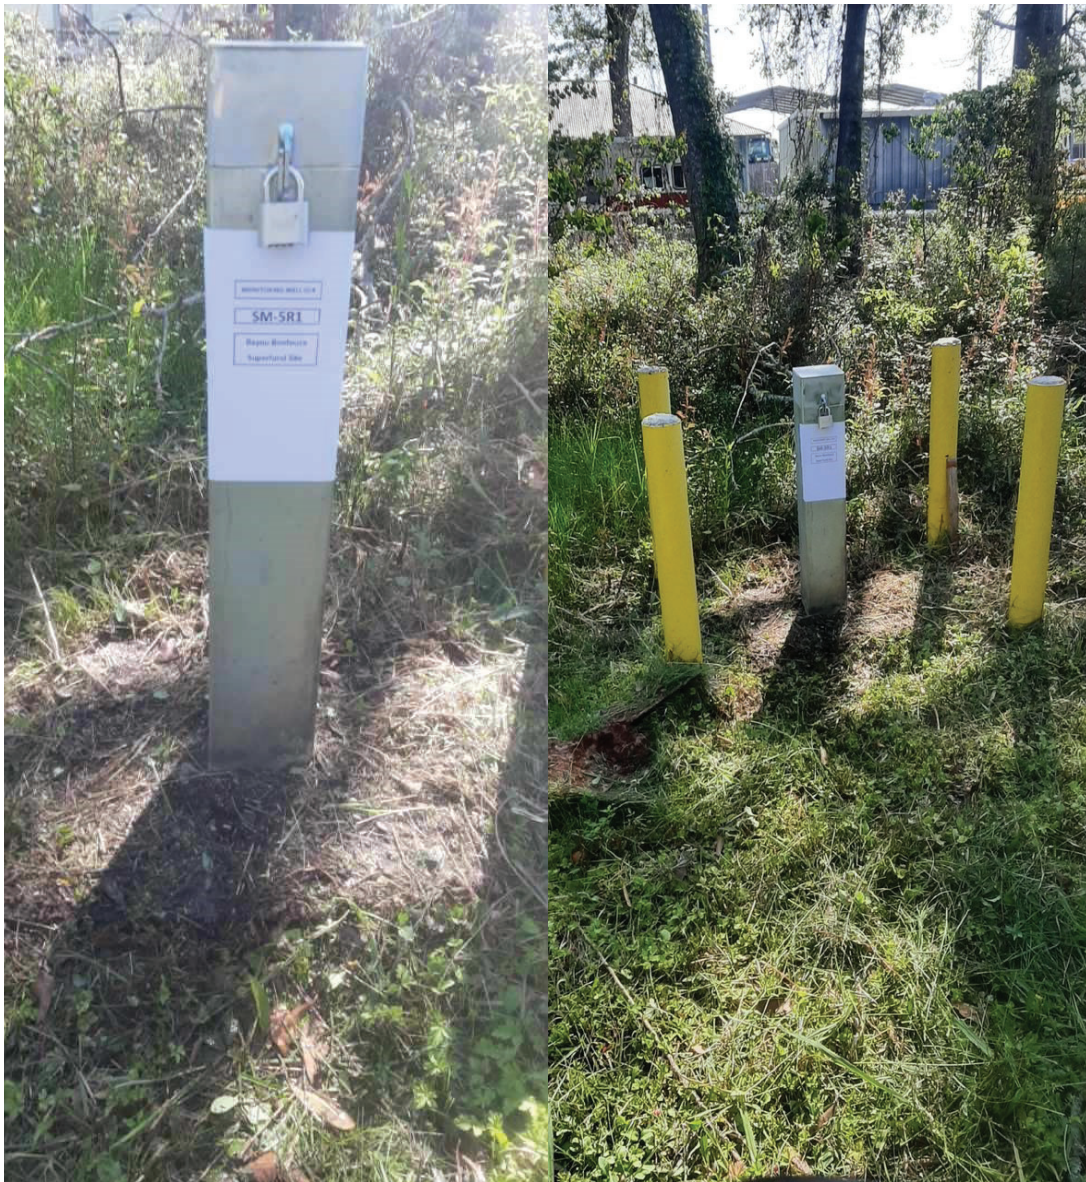
Participants then observed SM5-R1, the replacement subsidence monitoring well for SM-5 that had been damaged in 2015. The well was capped, locked and in good condition, but it was not labeled. [LDEQ labeled the well subsequent to the Site inspection, see photos in Appendix E.] Participants also viewed the former eastern drainage channel located east of the Slidell Public Works Department. Participants observed one of the November 2018 soil sampling locations near the drainage channel (TG46/LB9) as well as approximate sediment sampling locations. Participants also observed nearby SM-8, which was locked and secured. Participants then viewed Heritage Park, including parts of the park that fall within the site boundary. These areas appeared in good condition. Participants then observed Array 3 and the locations of the Array 3 recovery wells. Participants then went to the far western edge of the Site along St. Tammany Avenue and observed site fencing, which appeared to be in good condition.

LDEQ photos of labeled subsidence monitoring well SM-5R1. The labeling occurred after the site inspection.

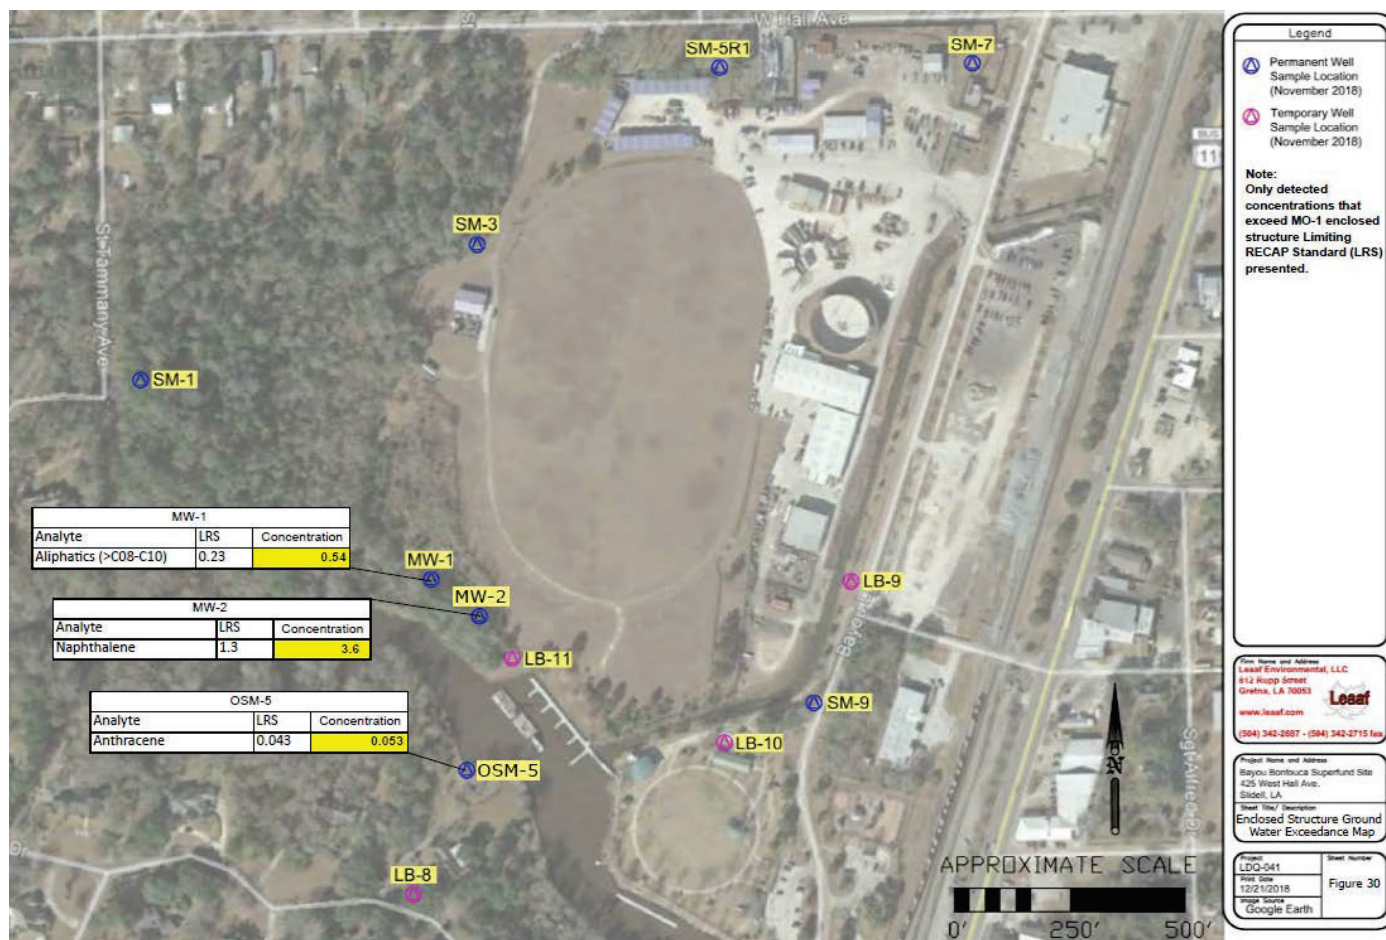
Figure H-4: Locations where the Limited Groundwater AOI-ES are Exceeded

As shown in Table H-3, the maximum detections of volatile COCs in groundwater were below the limiting RECAP Standard except for anthracene, aliphatics (>C08 – C10) and naphthalene. As shown in Figure H-4, the anthracene maximum detection was collected in the vicinity of the residential neighborhood on the southwest adjoining property at well OSM-5, while the aliphatics (>C08 – C10) and naphthalene exceedances occurred in MW-1 and MW-2, respectively. The limiting RECAP Standard for anthracene, 0.043 mg/L, is the water solubility; however, the detected concentration is well below the GWESNI of 37,000 mg/L, which is specifically for the indoor air exposure pathway. There are no enclosed structures in the vicinity of MW-1 and MW-2, thus, the exceedances of the GWESNI at these locations represent a future residential exposure concern if an enclosed residential structure were to be built in this area. The concentrations of aliphatics (>C08 – C10) and naphthalene were also reviewed to determine if the concentrations of these COCs remain below the limiting standard at the residential location, OSM-5. The concentrations of aliphatics (>C08 – C10) is 0.19 mg/L and naphthalene is 0.28 mg/L, with both concentrations below the limiting GWESNI indicating that vapor intrusion is also not a concern for these two COCs at OSM-5. Overall, there are no sample locations with concentrations greater than the GWESNI standard within 10 feet of an enclosed structure.
